THE DANGERS OF “I’VE SEEN THIS 100 TIMES BEFORE”

Written by: KRISTEN CEZAT, PT, DPT, NCS, ATP/SMS

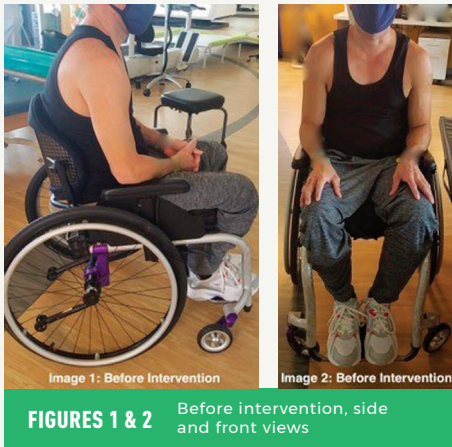
FIGURES 1 & 2 Before intervention, side and front views

needs based off of the ICF model. He arrived at the appointment to our inpatient seating clinic in a rigid frame, hybrid cushion and an after-market back rest that had been selected by his primary therapy team. This was a trial configuration to determine if these products matched his needs. He demonstrated posterior pelvic tilt, thoracic kyphosis, forward head and rounded shoulders, as well as mild hip abduction of his bilateral lower extremities; however, he was functioning well in the wheelchair (see Figures 1 and 2). The immediate problem list for this client included the stage 2 sacral and coccyx skin breakdown, poor shoulder/trunk positioning, hip abduction and decreased trunk balance.

head/neck positioning and transfer of weight distribution from ischial tuberosities to that of the sacrum and coccyx. Respiratory capacity may be affected by thoracic kyphosis. The long-term effects of posterior pelvic tilt positioning often result in sacral and coccyx deep tissue and pressure injuries, shoulder related pathology including impingement and rotator cuff injury from repetitive use of shoulder with poor mechanics, and neck pain due to the forward head posture and capital extension of the client's neck.

When paralysis is present, it is common for the client to seek a position of stability. Due to a decrease in trunk control and balance, the client often seeks stability through a posterior pelvic tilt. A posterior pelvic tilt increases the contact area of the pelvis on the seating surface and, as a result, provides a sense of improved stability. Despite the client's increased stability, posterior pelvic tilt contributes to a cascade of negative effects including thoracic kyphosis, forward

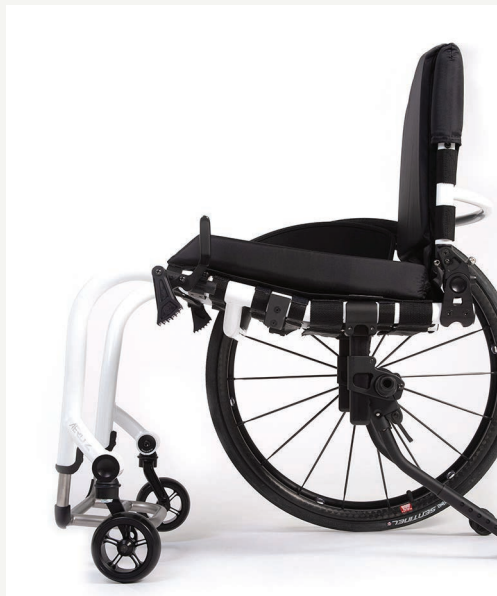
FIGURE 4 TiLite Ergonomic Seating

I realized that the interventions I traditionally use were not solving this client's positioning problems. A standard rigid frame, positioning cushion and rigid back support were not sufficient to achieve ideal positioning in this client's case. I consulted with the seating team prior to the formal wheelchair evaluation. The wheelchair supplier suggested that instead of trying to neutralize the pelvis and hips through a cushion only, a trial of a more aggressive wheelchair frame design to help capture the client's pelvis was warranted. Our seating team recommended a trial of "Ergonomic Seating" on his TiLite rigid frame. This addition to the frame was selected to provide a pelvic shelf in combination with seat tapering to give further support to the pelvis not achieved through cushion trials alone. The client was measured from the posterior buttocks to the anterior superior iliac spine with an inch added to determine where the wheelchair frame begins to bend upwards to create a shelf. This shelf aids to prevent the pelvis sliding forward into posterior

pelvic tilt positioning (see Figure 4). In this case, the ergonomic frame design achieved the positioning that the client and team desired. To address his hip abduction, seat taper through the frame was used with a back seat width measured at 15 inches and front seat width measure at 13.5 inches. This seat taper provided a more contoured fit to allow for neutral hip position. The tradeoff of seat taper was mild contact of the wheelchair frame against the client's lateral lower leg. Despite this contact, bony prominences of the lower

leg such as the fibular head were not impacted. With trial of the frame, skin remained intact without compromise.

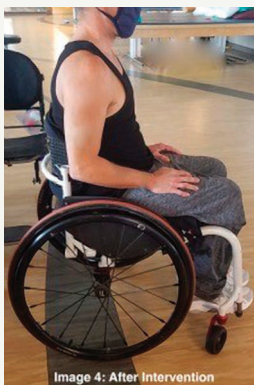
FIGURES 5 & 6 After intervention, side and front views

Image 4: After intervention

Image 5: After intervention

As a physical therapist, I was next concerned about the client's posture with dynamic movement in function and mobility. Could the client scoot forward in his seat for transfers in such an aggressive frame? Would his static postural improvements remain during propulsion and other dynamic activities? There are many considerations for wheelchair frame design beyond static seated positioning. In this particular client's case, this intervention worked during dynamic activities. This success helped to seal the deal for wheelchair frame design as it solved our client's priority problem list while providing independent mobility.

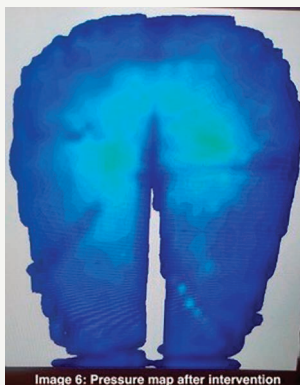
FIGURE 7 Pressure map after intervention.

Image 6: Pressure map after intervention
