REHAB CASE STUDY

Here Comes the Sun: How Orthotic and Prosthetic Sciences Unlocked Outdoor Accessibility Barriers

WRITTEN BY: Daniella Giles, PT, DPT, ATP, SMS

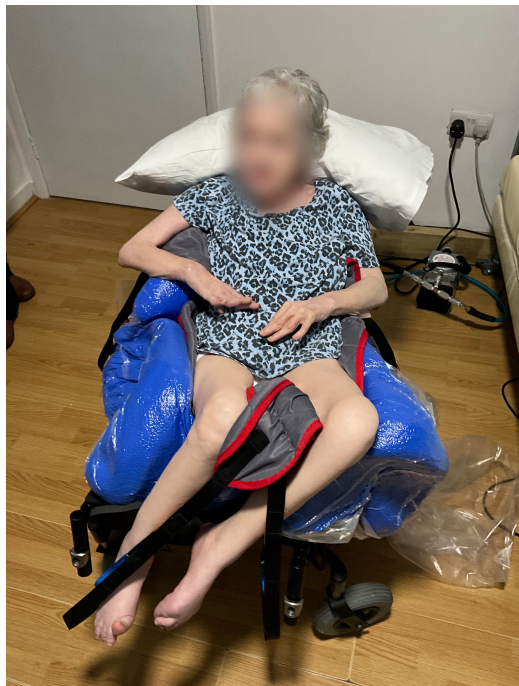
2. Shape capture assessment, frontal plane view. Glenda demonstrated a positive response.

Glenda was moulded at her home using the Ride Designs small base and shape capture system; (2., 3.) shape capture assessment, frontal view.

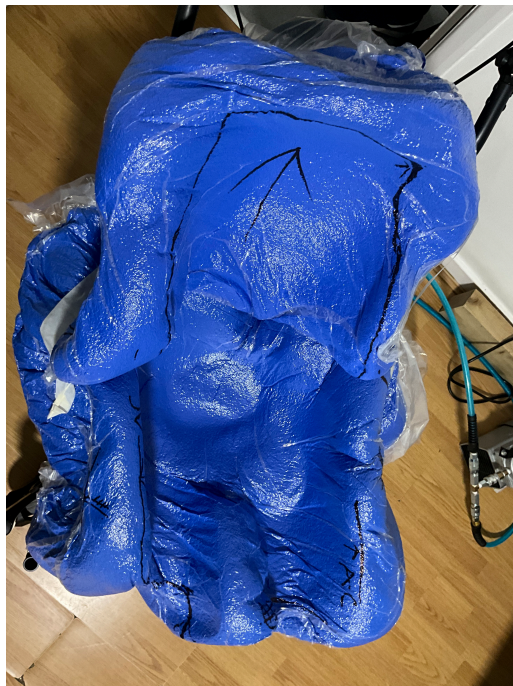
4. Glenda's final shape with trim lines.

Key points of support were shaping to encourage spinal extension within range and accommodation of lower limb position. (4. Glenda's final shape with trim lines). She sat in mould for approximately 15 minutes once the shaping was

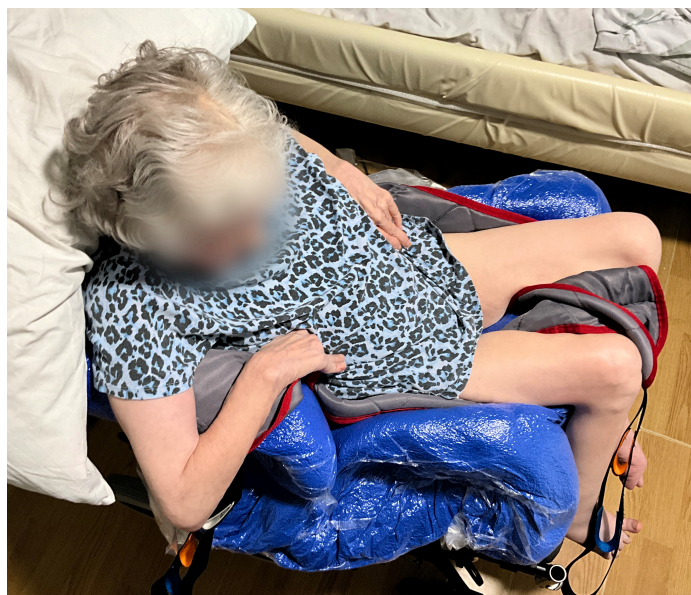
3. Shape capture assessment, transverse plane view.

Glenda demonstrated a positive response. A manual IRIS wheelchair was used as the moulding base, with the backrest recline set to a fully open position to accommodate her limited hip flexion and very tight hamstrings.

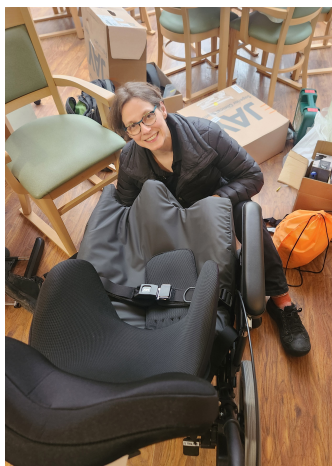
5. The assistive technology team setting up mobility base and seating components in accordance with goals.

On day of delivery, we reviewed our plan of care, photos and goals. We set up all equipment per stated goals.(5.) Minor modifications were made for optimizing fit. (6.) Glenda spent two hours in her new seating and wheelchair. She travelled in the wheelchair into a large dining room at her residential home and met several residents for the first time. (7.) She was able

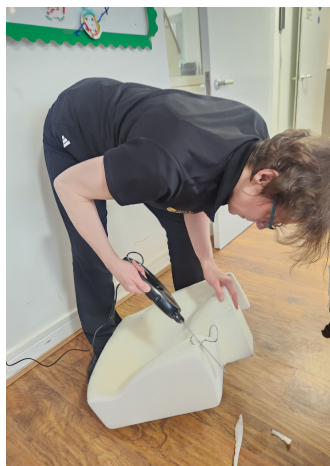
6. On-site modifications were made to optimize fit.

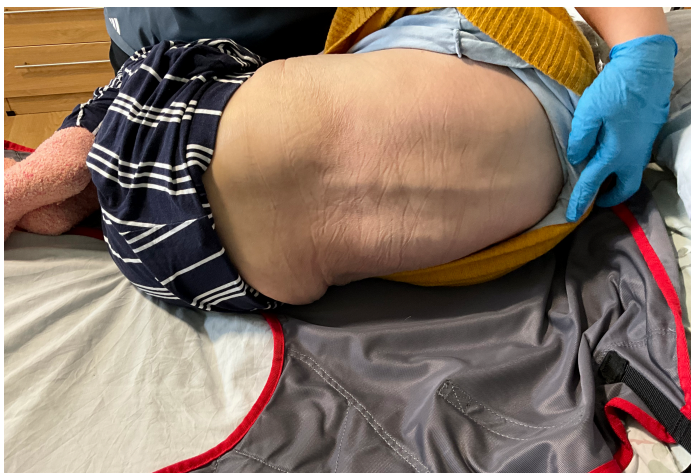
8. Skin checks performed every 30 minutes with positive response.

to sit on the patio in the direct sunlight. Skin over her sacral, thigh and gluteal areas was checked before and after, with no signs of increased redness or marking. (8.) She lifted her head several times and maintained the position for up to 10 minutes. (9.) Per staff interpretation, she showed no signs of fidgeting, facial expression or sounds that would suggest discomfort.

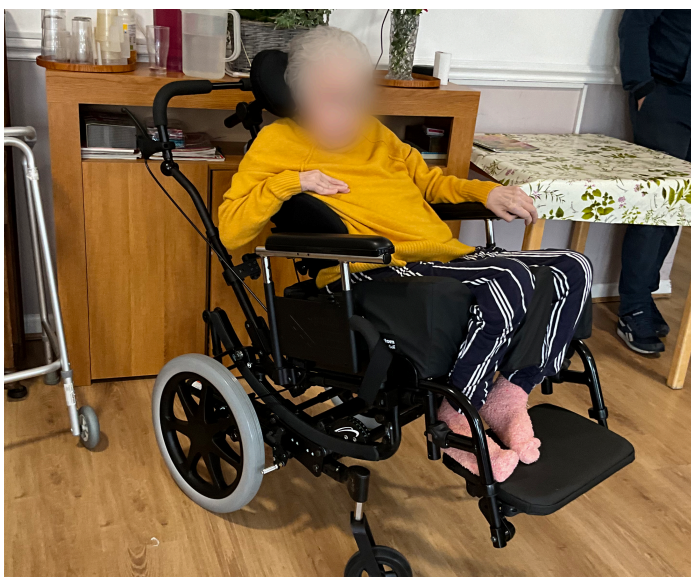
9. Glenda demonstrating improved head control and elevation off sternum.
